Manhole Inspection Summary

Manhole # S53M__016MH

Insp Date: **7/21/08 10:00 AM**

Location Address: **928 s ellwood av**

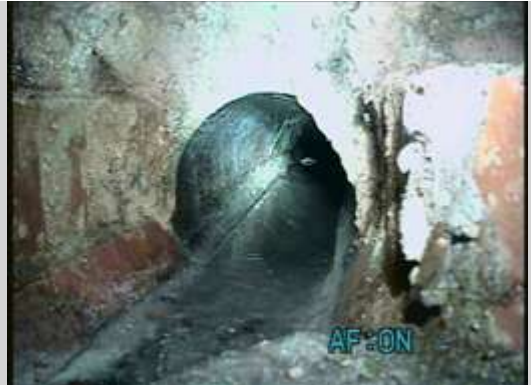
12 O'Clock Outflow

8 in. Circular Gravity Sewer
Pipe Out @ 12 O'Clock

Pipe Material: **Clay** ☐ Pipe Lined

Invert Depth: **9.50** (ft.) Flow Characteristics: **Slow**

Deposits: ☒ None ☐ Mud ☐ Sludge ☐ Debris ☐ Grease

Infiltration: **None** Pipe Seal Cond: **Unknown**

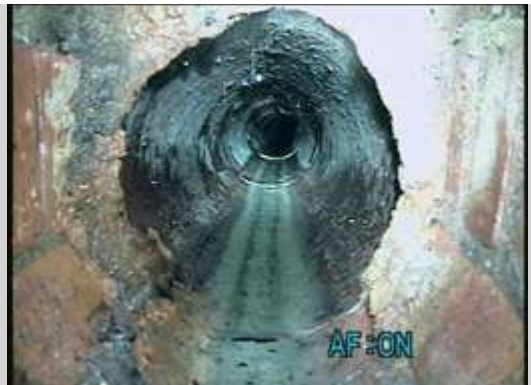
3 O'Clock Inflow

8 in. Circular Gravity Sewer
Pipe In @ 3 O'Clock

Pipe Material: **Clay** ☐ Pipe Lined

Invert Depth: **9.40** (ft.) Flow Characteristics: **Slow**

Deposits: ☒ None ☐ Mud ☐ Sludge ☐ Debris ☐ Grease

Infiltration: **None** Pipe Seal Cond: **Unknown**

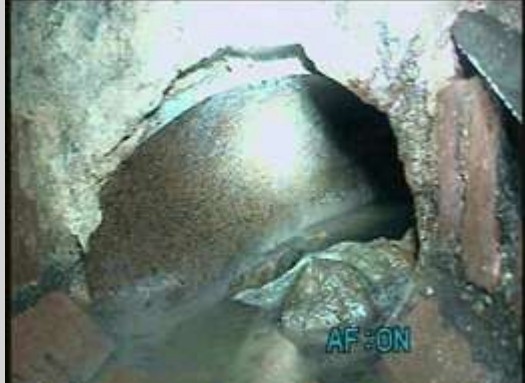
6 O'Clock Inflow

8 in. Circular Gravity Sewer

Pipe In @ 6 O'Clock

Pipe Material: **Clay** ☐ Pipe Lined

Infiltration: **None** Pipe Seal Cond: **Unknown**
